Outfall 2 Assessment

326 – 04 Selfridges Drainage Management Plan

Reason for Issue	Review of capacity of OF2 for new LG toilets	Author	T Strachan
Date	03/04/2017	Reviewed

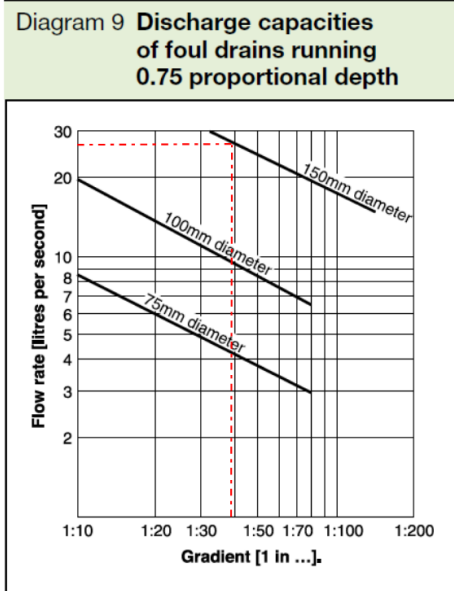
Figure 1 - Discharge capacity (Approved Document Part H)

Figure 1 shows the maximum discharge capacity for Outfall 2 of approximately 27l/s, therefore indicating that the Outfall is slightly undersized for the additional flows and the contingency for future changes.
